OHIO CITY DEVELOPS MANHOLE

Rehabilitation Program

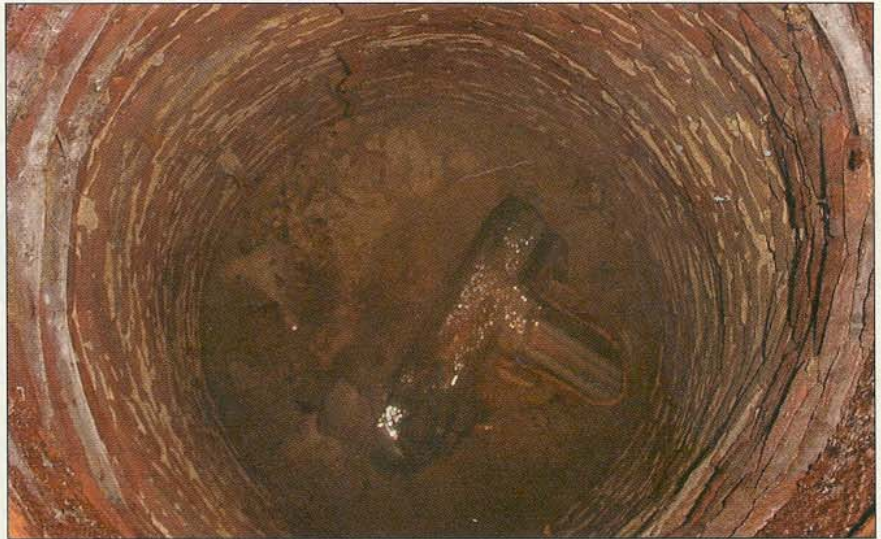
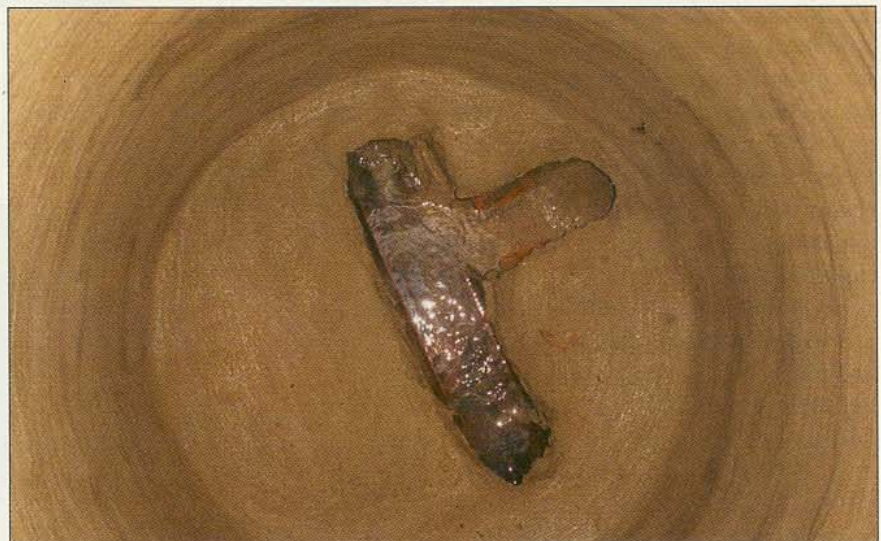
Top: A corroded brick manhole before the cementitious rehabilitation. Bottom: The manhole after rehabilitation with the Strong-Seal® MS-2A liner material. Because many of the manholes were located in difficult-to-access rear easements, the application equipment had to be able to pump materials long distances.

four manholes per eight-hour work day, including power-washing, removing steps, repairing bench and invert when necessary, and applying mortar to walls and bench. Divisional records indicate that it takes an average of 12.67 labor hours to completely rehabilitate a manhole (including installation of chimney kit). The average cost to rehab a 10-ft deep manhole is just under \$750. This includes materials, labor/benefits, safety equipment, and vehicle/equipment depreciation.
