Tuscarawas County, Ohio

Replaces

deteriorated precast manholes with

RhinoUSA HDPE MANHOLES

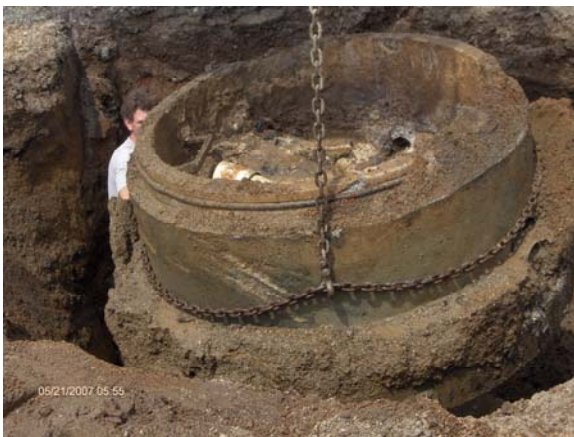
This is a picture of the old manhole as it is being removed. The manhole shows clear signs of hydrogen sulfide attack. The walls have completely deteriorated and are beyond rehabilitation by conventional methods.

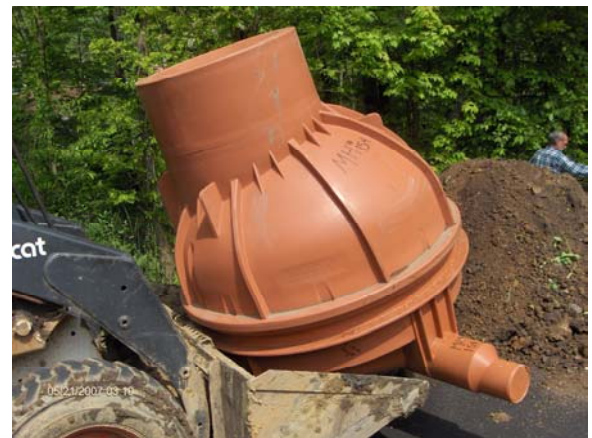
This photo shows how easy it is to transport the new Rhino HDPE manhole to the site. Note the sewer connection on the bottom.

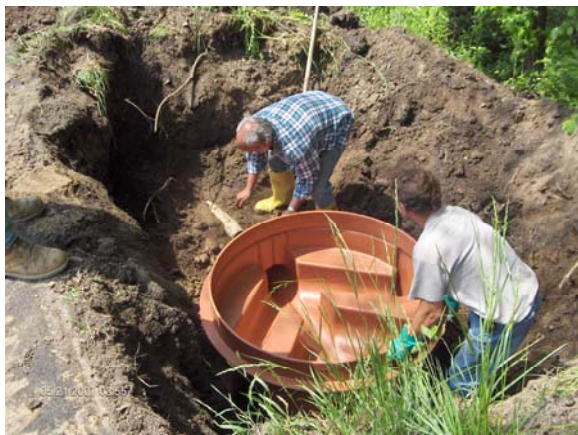
The Rhino HDPE Manhole is placed in the excavated hole by hand. This is a picture on only the base. Notice the built in flow channels.

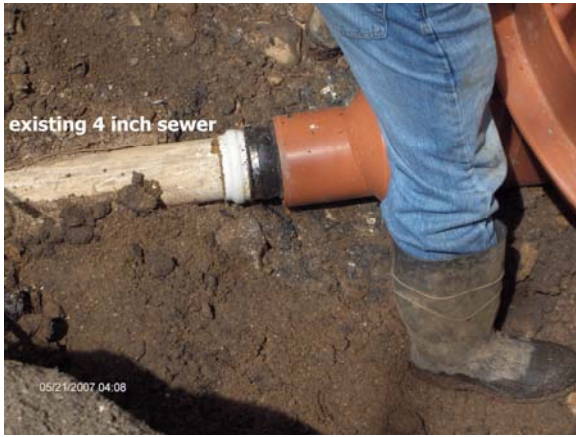
The new Rhino HDPE manhole is now connected to the existing sewer connection. Rhino manholes can be designed to fit your job requirements; from height and traffic loading to depth and invert design needs. Specify Rhino HDPE manholes for new construction or replacement.
