DOWN THE CHIMNEY

Here are some cost-effective ways to target inflow and infiltration in an area of infrastructure that provides high return on repair investment

By John Keffer

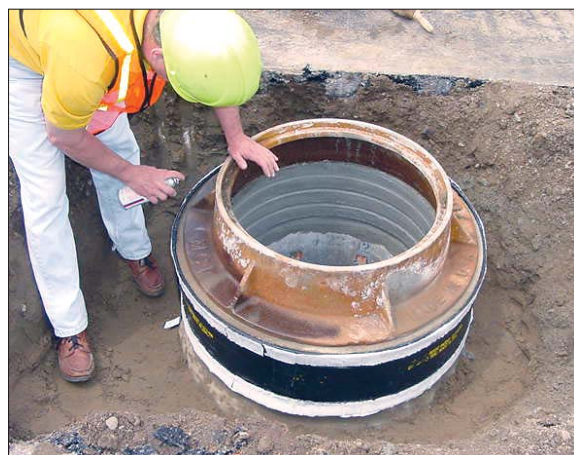
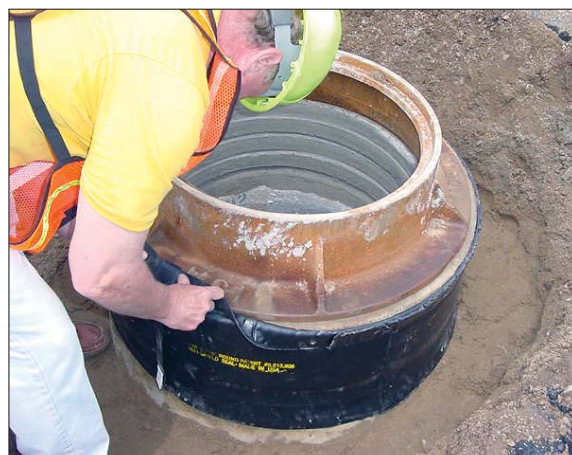
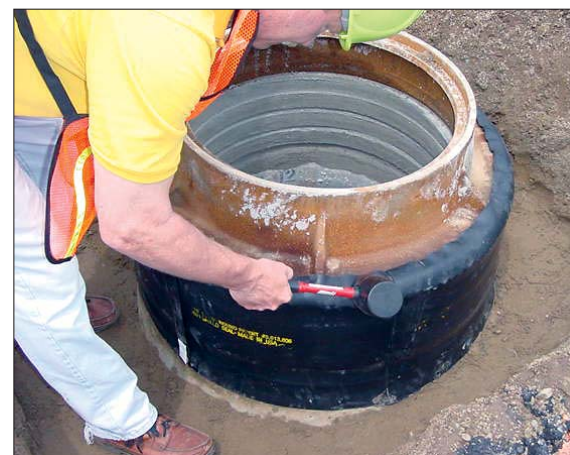
This sequence shows the application of an external rubber manhole seal. From left, the surface is prepared, the seal is pulled into place, and the seal is tapped into final position with a hammer.

For rubber seals, the surfaces of the riser ring and the manhole chimney are

cleaned with a wire brush. The seal is stretched over the casting and cone to the correct position. The surface of the riser ring base is then primed, and the rubber seal, with mastic adhesive, is pulled up around the ring base and tapped down with a hammer. Installation takes about 10 minutes per manhole and requires no special tools.

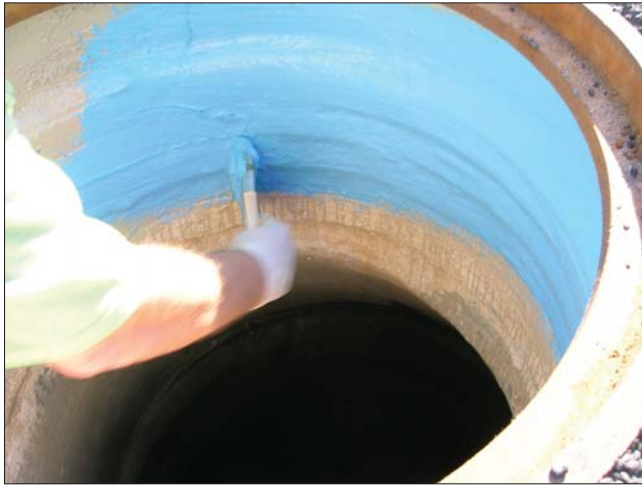
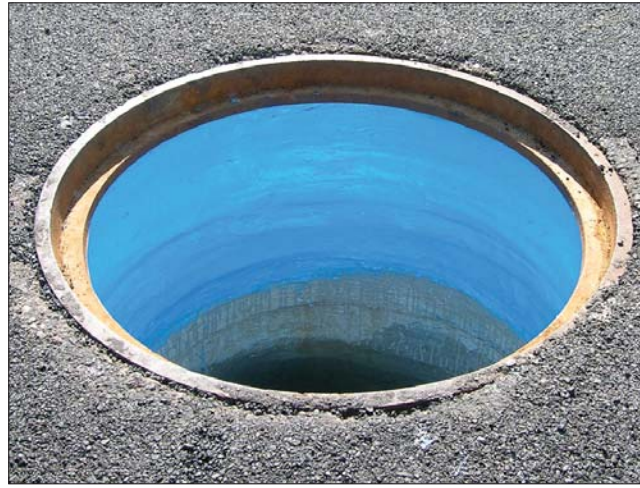
A urethane internal seal is applied to a manhole chimney. The finished project is at the right.

Urethane internal seals require surface preparation that includes stoppage

of leaks, sandblasting, pressure washing and drying. The surface is then primed, and a urethane sealer is applied with a brush to a thickness of about 1/8 inch. This type of seal conforms to irregular-shaped manholes and provides a custom-fit seal.
